Facade Condition Assessment Report

Wall ID	7709-BW
Location	36.XXXXXXX, -78.XXXXXXX
Building Name	REDACTED
Building No	7709
Assessor	John Suschak
Assessor Date	02/13/2023
Mission Dependency Index	70
Any Known Safety Risks?	No safety issues were observed.

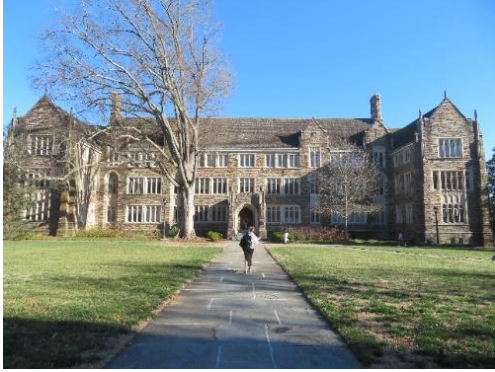
1	Clean and Seal - Masonry power wash and seal	64,073 (SF)	2	Clean masonry walls and apply clear water repellent material

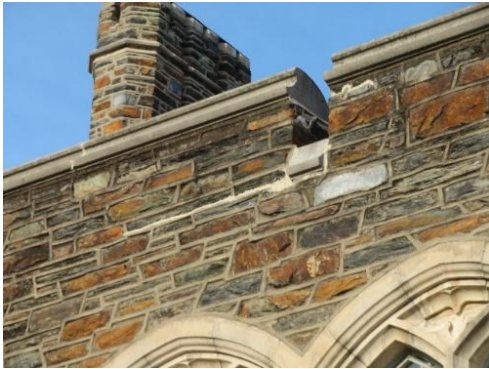
2	Tuckpointing - Stone or linear spot pointing	4,396 (LF)	20	Cut out areas of open masonry joint and install new mortar spot pointing

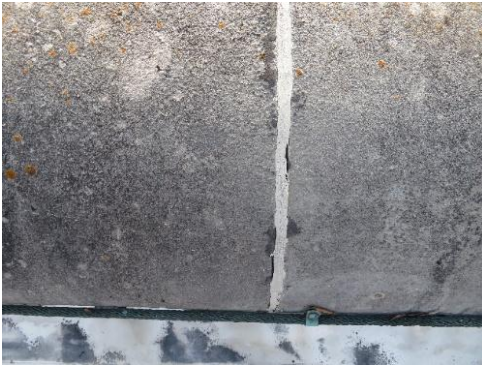
3	Tuckpointing - Stone or linear spot pointing	6,080 (LF)	20	Cut out areas of open masonry joint and install new mortar spot pointing

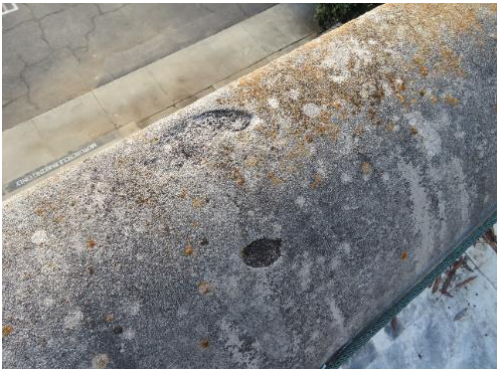
4	Patching - Stone masonry patching	25 (SF)	120	Remove loose material and install approved stone patching material

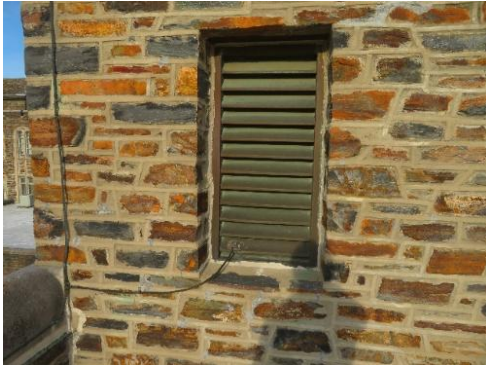
9

Penetration Sealant -
Failed and open sealant
joint

Cut out joint and backer rod and
replace sealant
