Facade Condition Assessment Report

| Wall ID | 7709-BW |
| Building Name | REDACTED |
| Building No | 7709 |

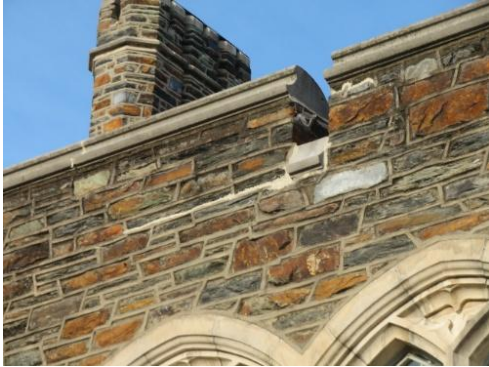
| Defect Overview Image | Defect No. | Defect Type | Quantity | Unit Cost | Repair Specification |
|--|---|--|---|---|--|
| | 2 | Tuckpointing - Stone or linear spot pointing | 4,396 (LF) | 20 | Cut out areas of open masonry joint and install new mortar spot pointing |

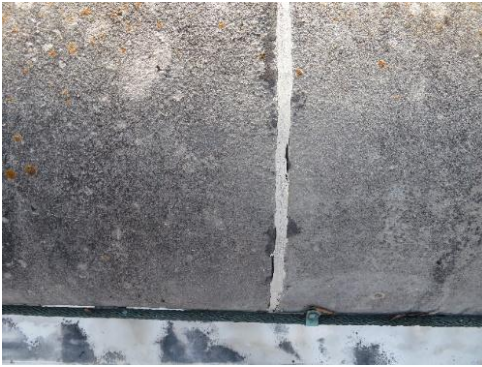
| Defect Overview Image | Defect No. | Defect Type | Quantity | Unit Cost | Repair Specification |
|--|---|--|---|---|--|
| | 3 | Tuckpointing - Stone or linear spot pointing | 6,080 (LF) | 20 | Cut out areas of open masonry joint and install new mortar spot pointing |

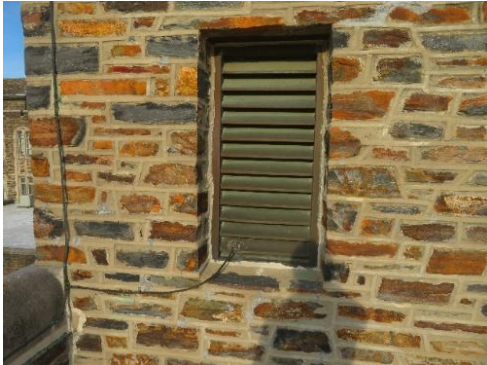
9

Penetration Sealant -
Failed and open sealant
joint

Cut out joint and backer rod and
replace sealant
